**SAS Superstructure**

Daily Diary Report by Bid Item

Diary #: 047 Const Calendar Day: 242 Date: 08-May-2010 Saturday

04-0120F4
04-SF-80-13.2/13.9
Self-Anchored
Suspension Bridge

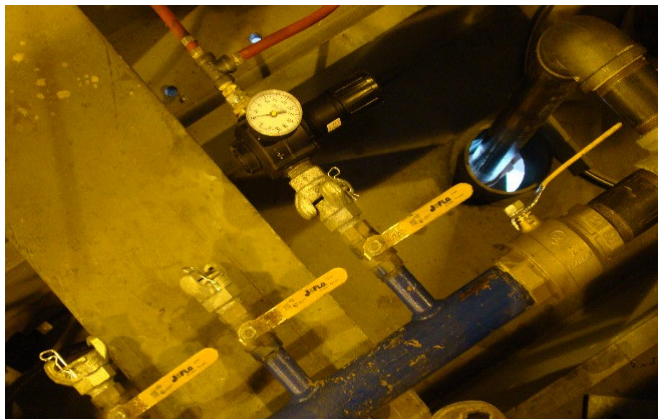
Pressure gauge for the mandrel hoses.

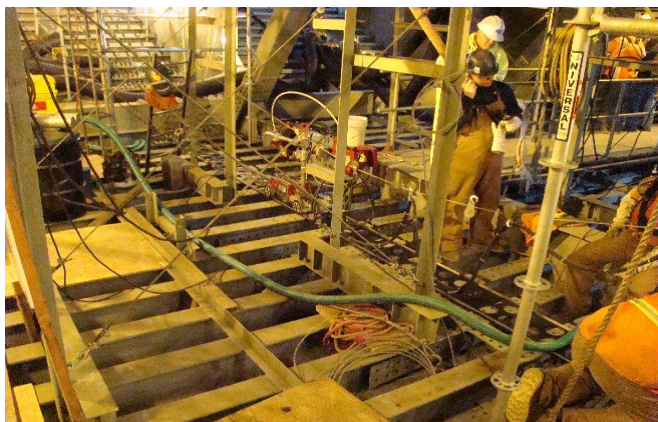
It should be noted that the survey was done from 8:40am to 10:00am while the top deck backer bar for OBG splice joint 4E/5E was being welded. The first ROOT pass weld at the bottom of OBG splice joint 4E/5E began at 1:00pm with approximately 6m of weld done at 1:40pm. Also lift 6E was on the temporary truss/cradle with the front end of the lift at Truss Panel Point E38.

ABF welders working on the bottom splice joint ROOT weld for OBG 4E/5E joint.
